Fault Description: The usual causes of a 1029T evaporative cooler with knocking or tapping sounds when the fan is in rotation are as follows.

Realignment of Motor/Fan to Cowl Procedure

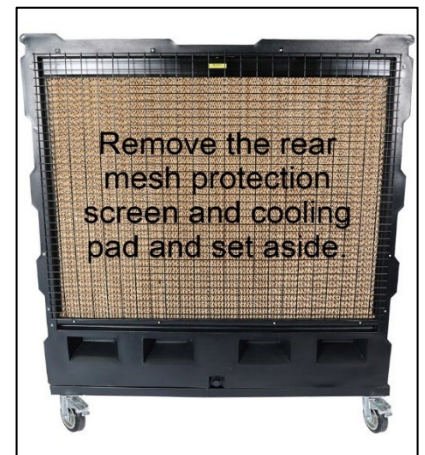
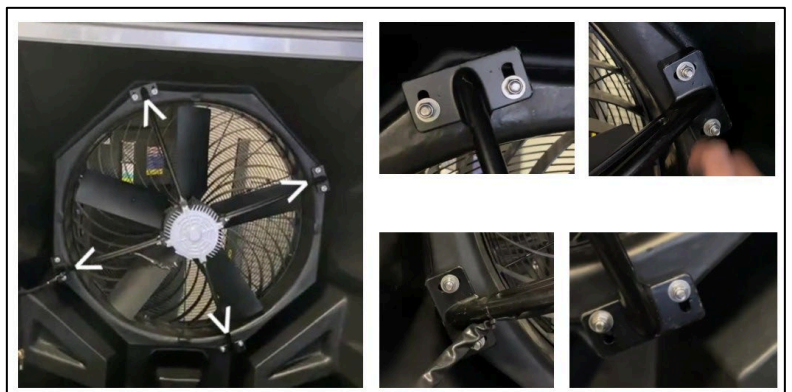
- The fan/motor mountings are not concentric with the cowling causing the fan tips to contact the cowling.

4. Adjust the fan motor mounts position until there is even clearance between the fan tips and the inside of the cowling throughout full rotation.
5. Tighten the fan motor mounting nuts and manually spin the fan to check the clearance between the fan tips and the inside of the cowling to ensure no contact.
6. If additional clearance is required follow steps 4 and 5 until the fan is concentric with the cowling and no contact is made between the fan tips and cowling.

Once clearance between the cowling and fan blades has been achieved, please reassemble the evaporative cooler, fill with water and test for correct operation.
