Bleeding Instructions

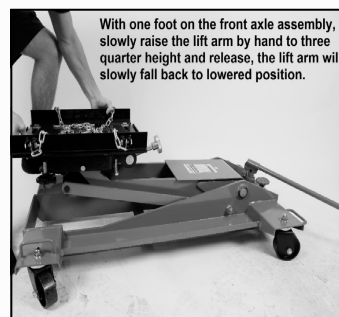
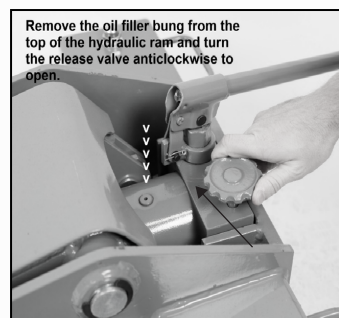
1. Remove the Filler Bung and if required, refill with *32 Grade Hydraulic until the oil is approximately 6mm below the filler hole then replace the Filler Bung.
2. Leaving the Pump Handle in the lowered position, open the release knob one eighth turn anticlockwise.
3. With one foot on the front axle assembly, slowly raise the lift arm by hand to three quarter height and release, the lift arm will slowly fall back to lowered position
4. Remove the oil filler bung from the top of the hydraulic ram and turn the release valve anticlockwise to open.
5. Replace the filler bung and pump the handle up and down quickly several times to bleed air from the pump system
6. Recheck the hydraulic oil level and refill to 6mm below the fill port if required before replacing the filler bung
7. If necessary, repeat the process steps 2 to 6.
